# Manhole Inspection Summary

Manhole # S33KK1021MH

Insp Date: **2/28/07 10:51 AM**

**Location** Address: **208 MILBROOK RD**

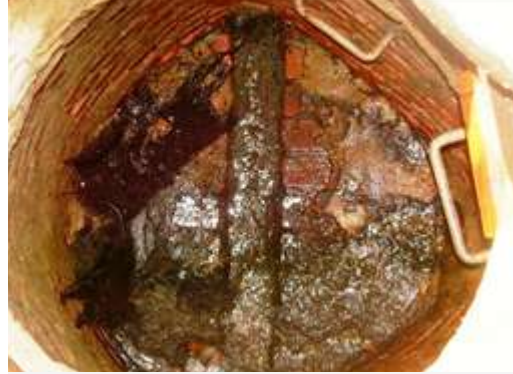
Top View

Barrel root intrusion. Bench and Channel debris.

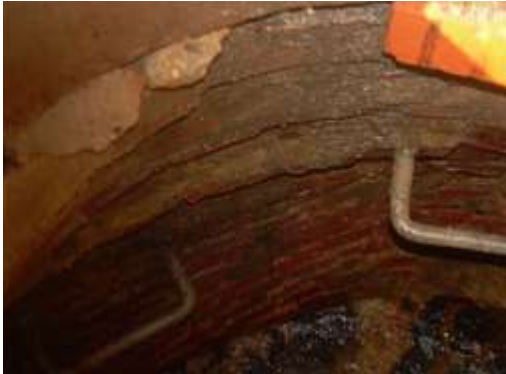
Defect

Frame leaks. Adjustment deterioration and infiltration. Corbel and Barrel infiltration.

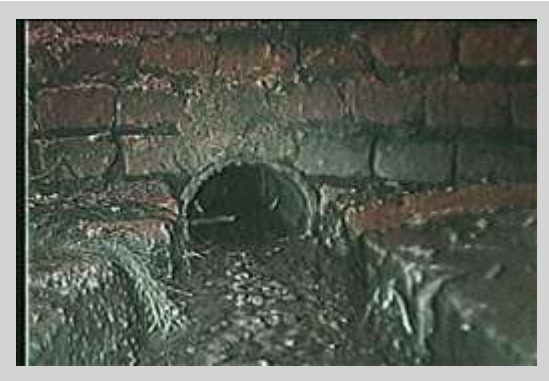
### 6 in. Circular Gravity Sewer Pipe Out @ 12 O'Clock

Barrel deterioration and infiltration.

Deposits: ☐ None ☒ **Mud** ☐ Sludge ☒ **Debris** ☐ Grease

Silt Depth: **1** (in.) Deposits Extent: **Medium**

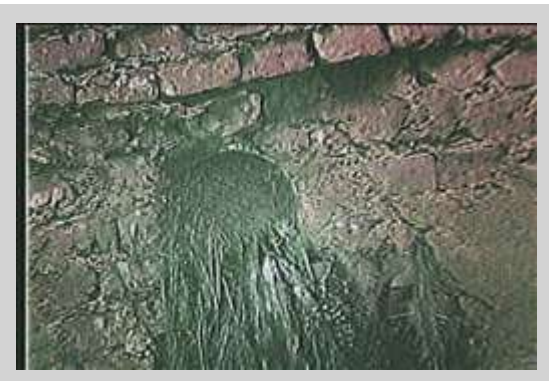
### 6 in. Circular Gravity Sewer Pipe In @ 6 O'Clock

Comments **The I6 pipe in is filled with roots.**

Corbel deterioration and infiltration. Barrel deterioration, root intrusion and infiltration.

Infiltration: **Evidence** Pipe Seal Cond: **Roots**

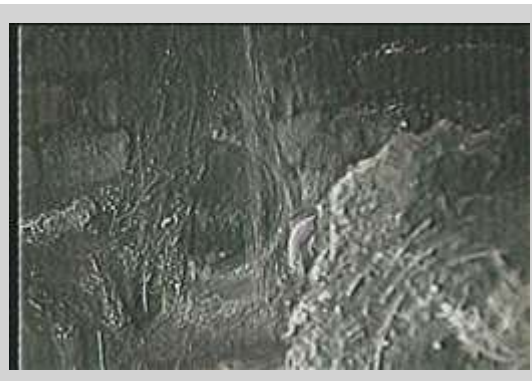
### Drop In @ 6 O'Clock

Barrel deterioration, root intrusion and infiltration. Channel root intrusion.

Drop Condition: **Clogged**
